# Measuring Soil Loss and Sediment Deposit on Low Volume Rural Roads in Mt. Elgon Sub County, Trans-Nzoia and West Pokot Counties

James Okinyi Manyara, Elias Ucakuwun, Thomas Munyao. Measuring Soil Loss and Sediment Deposit on Low Volume Rural Roads in Mt. Elgon Sub County, Trans-Nzoia and West Pokot Counties. *Applied Engineering*. Vol. 1, No. 1, 2017, pp. 20-31.

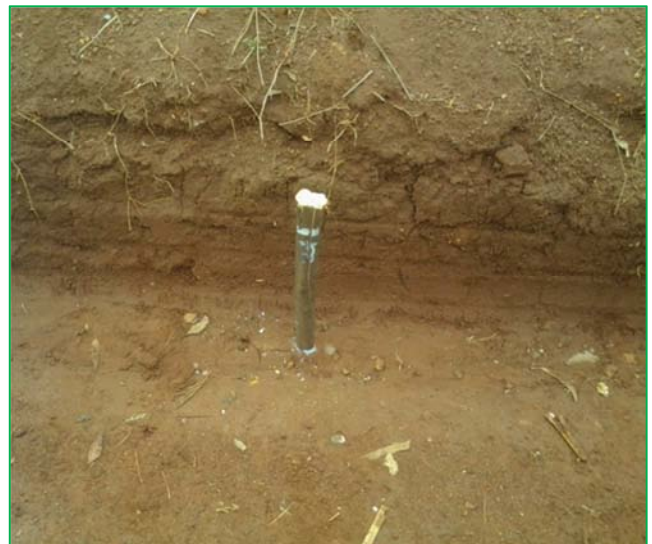
*Figure 2. Peg placement at 0+500 on Kuywa-Kopsiro Road.*

The pins were of standard average length of 70 cm which were driven into the soil to give a firm stable datum: 20 cm was typical, less for a shallow soil, more for a loose soil approximately 30-45 cm driven into the ground. The pins had an average diameter of 50 mm; thick pins could interfere with the surface flow and could cause scour. A total of 86 pegs were driven into the ground (see Table 1 for peg distribution per road). Rock and tree roots painting was also done in sections of West Pokot on areas with rocky road surface and zones were pegs could probably be plugged out or infested by pests like termites.

The first readings were done after the pins had been driven to the ground and this was taken to be the datum for consequent readings. To obtain the volume of sediments and soil deposited or eroded on the road side drain in each sedimentation point, the length and width of area covered by sediment was estimated by direct measurements. The average depth of sediments was calculated after taking five successive readings for a period of three months, during the rainy and dry seasons of December 2013, January and February 2014 respectively. The average readings were then used to calculate the volume of soil eroded or deposited by measuring the length of the back slope to the slope and multiply by the total length of the road to the next peg. The volume of sediments covering an area was calculated from the formula:

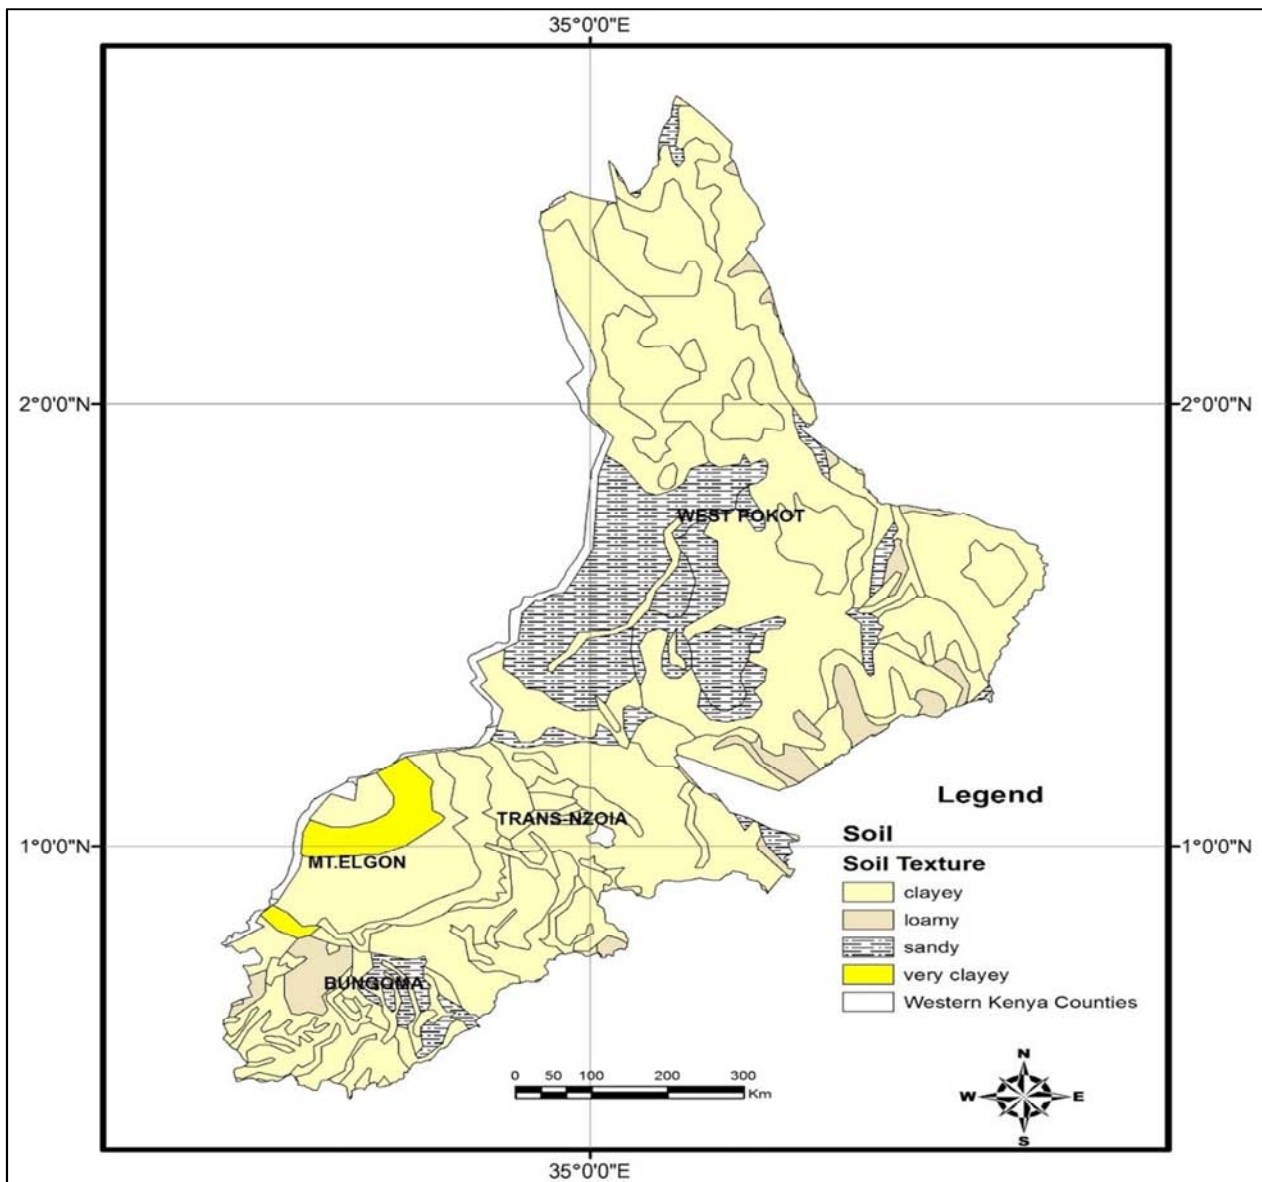
**Figure 3.** Distribution of soil types in the study area.

Soil types and infiltration rates were determined by obtaining information from images adopted from ILRI [9]. Soil texture and types were obtained by observation in the field through texture and secondary review of data. The soil descriptions of the study zones are shown below (Figure 3).

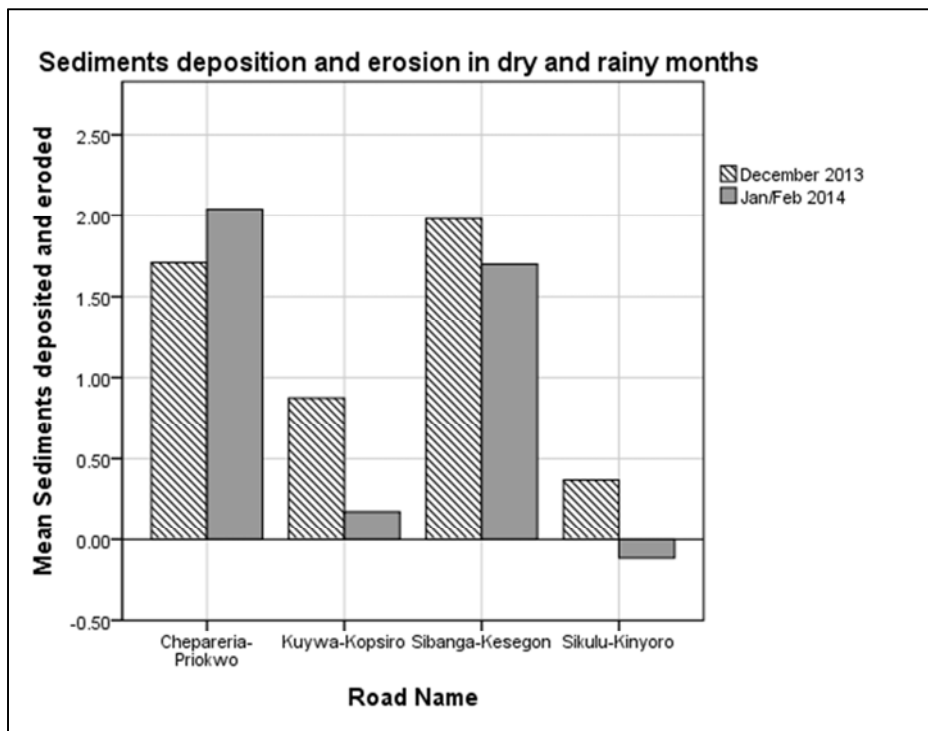
Figure 4. Sediments deposited and eroded in December and January.

In the month of December it was observed that there was higher erosion compared to other months January and February, where erosion was minimal. Mt. Elgon County had the highest rate of erosion in all the months while Sibanga-Kesegon a class E road in Trans Nzoia County had the highest rate of erosion in the county and the lowest during the dry seasons. This was due to the grassy surfaces formed after the rains ceased in the months of December, by February 2014 Sibanga Kesegon road had the lowest rate of erosion. At Mt. Elgon is a stiff terrain and this could be the reason behind its high rates of erosion and deposition.

There was also a great disparity of readings in the month of December with a standard deviation of 4.39 and January/February had a standard deviation of 2.62. The deviation in the month of December is due to high rates of erosion and deposition caused by rains unlike in the months of January where agents of erosion were minimal. Weather is an aspect that influence soil erosion. There was a significant correlation between sediments change and weather seasons and in the month of December ( $r_s=0.472$ ) and in January/February ( $r_s=0.267$ ).

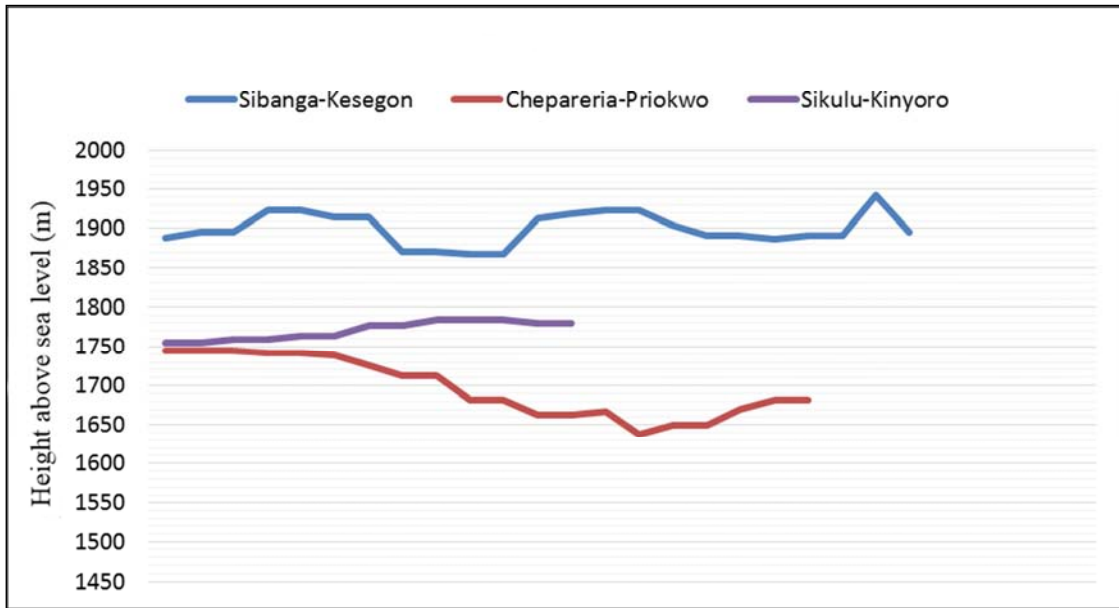
Figure 5. Road terrain simulation using height above sea level (m).

Terrain is one of the factors that influences soil erosion, the study considered collected data for terrain of road by use of height above sea level. The correlation between height above sea level and sediments eroded or deposited was significant with an ( $r_s=0.522$ ). In West Pokot roads and Sibanga-Kesegon there was an insignificant relationship between sediments and terrain and this might be due to the

undulating terrain and most of the erosion is due to climatic factors and human factors. In Mt. Elgon sub-county there was a significant relationship between sediment deposits and terrain ( $r_s=0.530$ ) whereas in Kinyoro-Sikulu road there was negative significance of ( $r_s=0.032$ ). Chepareria-Priokwo had a negative significance of  $r=-0.381$ , while Sibanga-Kesegon had a significance of  $r=-0.396$ , this shows that when height decreases in the roads sediment volume increase which also implied that when height reduces sediments volume increase.

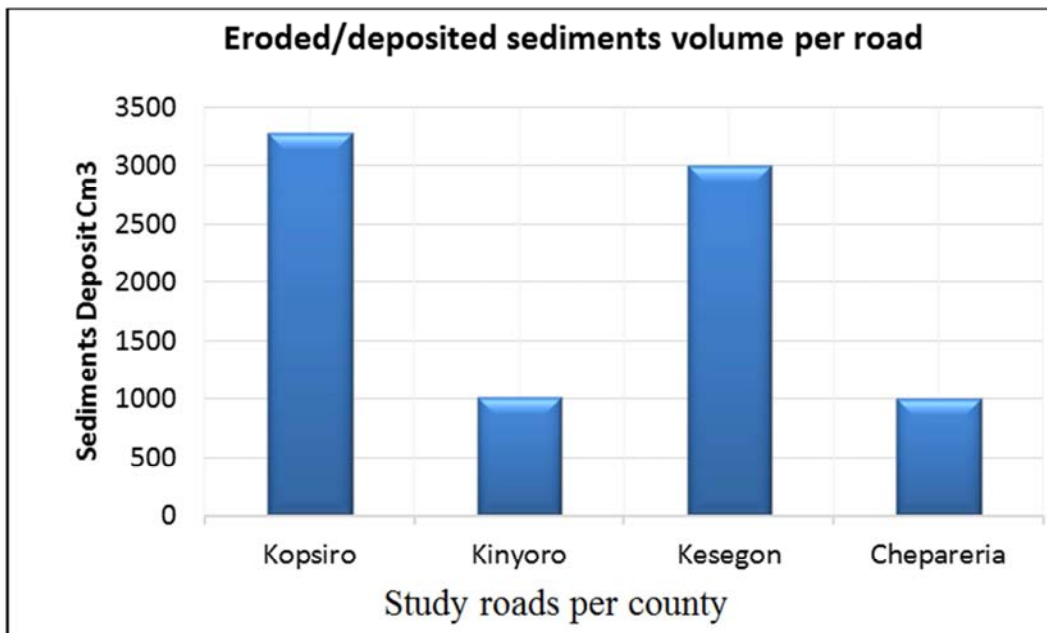
Figure 6. Total sediments volume (deposited and eroded) per road.

Eroded sediments per road in all the three counties were calculated and this included sediments from both erosion and deposition. Sediments loss or gain was calculated at intervals of placed pegs. The final data was computed and Mt. Elgon County had the highest loss in sediments, 3284.64 cm<sup>3</sup> of

sediments moved and deposited. West Pokot-Chepareria-Priokwoi road- had the lowest volume of sediments at 1004.124 cm<sup>3</sup>. In Trans Nzoia county Sibanga had the highest number of sediments moved at 3009.512 cm<sup>3</sup>. Mt. Elgon county road had the highest number of sediments this could be due to lack of soil control work in the areas.

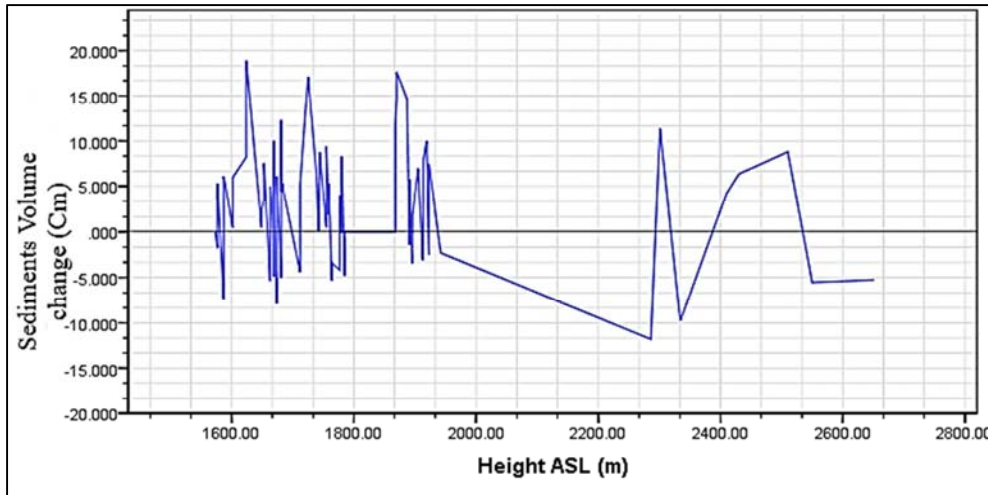
Figure 7. Graph of sediment loss and deposition versus Height above sea level.

Sediments eroded and deposited were also plotted against height above sea level and grouped per road class for each study road. High sedimentation levels were recorded in Kuywa-Kopsiro area with sediments rising above 200 cm<sup>3</sup> after 2260 m above mean sea level. This was also

experienced in parts of the lower lying road section which range between 33 cm<sup>3</sup>– 98.7 cm<sup>3</sup> being deposited in three months period this is was as a result of a newly redone road with deep ditches and loose soil along its slopes and back slope which became source of sediments during rainy season.

The road stretches 26+100 km from 1573 m-2651 m ASL, the road traverses through steep terrain with gradients greater than 50°. The above graph (Figure 7) shows variation of soil erosion and sedimentation along all the roads, the negative value signifies erosion while the positive shows deposition. It was observed that between 2300-2400 m ASL there was a drastic increase in erosion, this area signifies the slopes of Mt. Elgon which covers 2 km of the road section and it

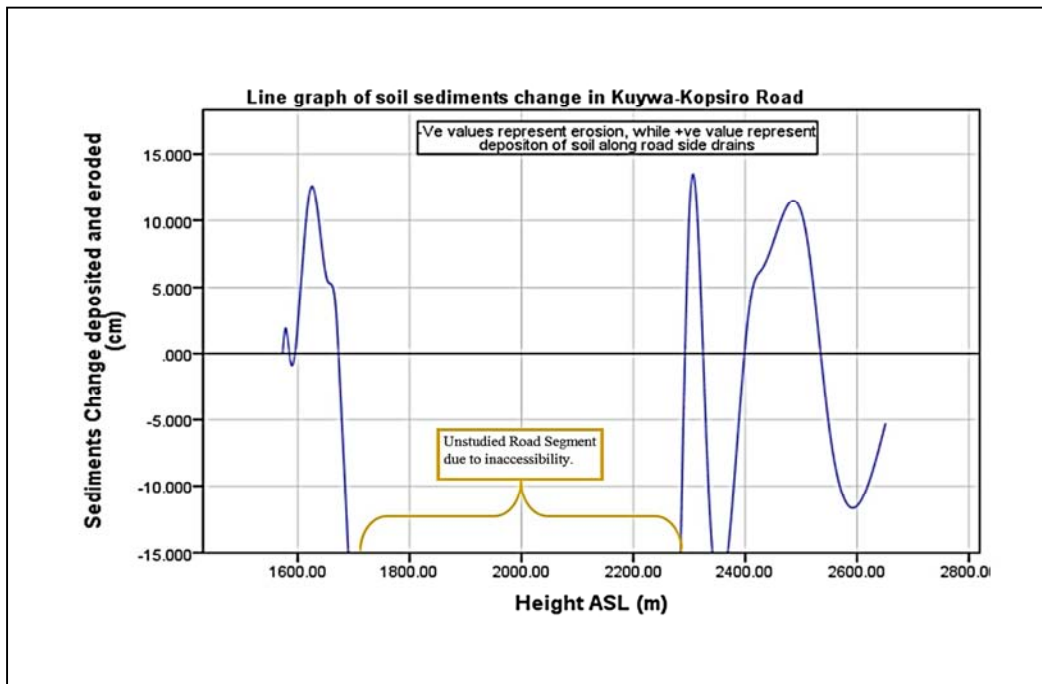
Figure 8. Sediments change deposited/eroded in Kuywa- Kopsiro road.

recorded -11.1 cm change in sediment movement. The area is characterized by steep slopes with no soil control structures and scanty vegetation. Between 1800 m-2200 m ASL the area was not studied in Mt. Elgon region because of the terrain and inaccessibility of the road, the inaccessible part is 2 km from Kapkateny River to Chemisto Primary school in C51 road leading to Kapsokwony, this in the (Figure 8) below is represented by the missing values after 1800 m to 2200 m.

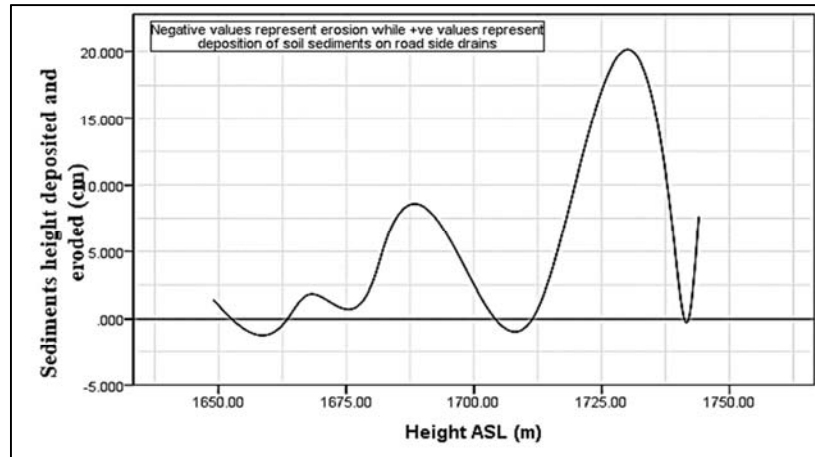
Figure 9. Sediments change versus Volume in Chepareria-Priokwo.

In West Pokot County the terrain ranged from 1650 m-1725 m ASL and the highest deposition was recorded at 1725 m ASL which was at 2+800 km mark. The high rate of sand

sediments was attributed to transportation by water from 0+500 km, the relief could be a factor contributing to the sedimentation, despite the availability of a mitre drain in the side drain and a cross culvert, their functionality was impaired by the massive transportation and deposition of debris.

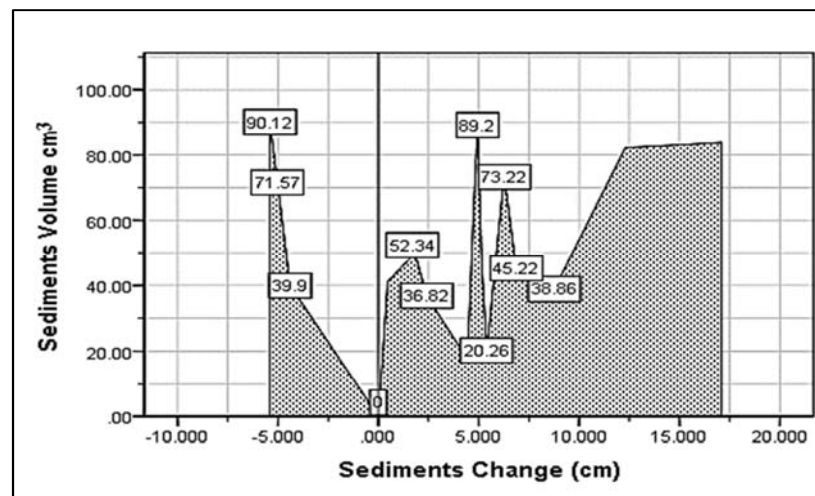
Figure 10. Sediment volumes in West Pokot.

The average deposited sediments in west Pokot was higher than the eroded sediments from the road see (Figure 10

below). The volume of eroded sediments was less at 202.41 cm<sup>3</sup> compared to deposited sediments which was 356.11 cm<sup>3</sup>. The general trend of west Pokot roads was deposition, while erosion accounted for less than 40% of soil movement and deposition was higher on lower sides of the road and along dry river beds. The probable source of sediments could be from adjacent farms or transported from distant locations by water action. The sedimentation materials were deposited on the roadside damaging road soil control works and blocking culverts, shattering drifts and bridges in the area.

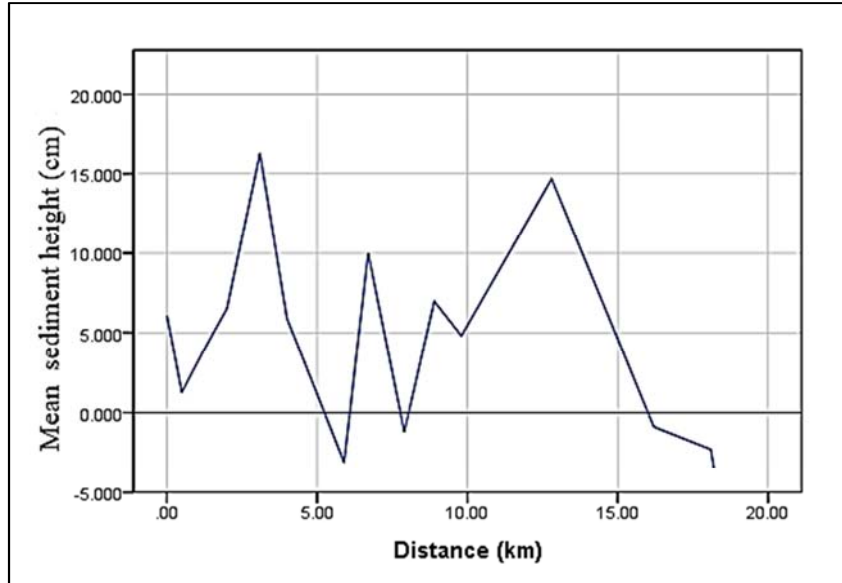
Figure 11. Mean sediments height versus road distance (Sibanga-Kesegon).

Sibanga-Kesegon lies on the slopes of Cherangani hills along Kapkanyar Forest through Kapchorwa tea factory. The road ranges from a rolling terrain to undulating land. The road ranges from 1867-1943 m ASL and the studied road was 19+200 km with a total of 24 pegs. The general trend of the road was erosion. Erosion was higher at 3+100 km with an average high of 17.63 cm and low of -3.467 cm at 18+200 km (see Figure 11), and this was due to anthropogenic activities in the area. The road between 2 km-5 km was being redone during the third and fourth reading of the study, the

high rate of sedimentation was also attributed to the rolling terrain and newly done side drains which retain much debris. The high rate of sediments at 12 km is due to poorly placed of soil erosion control works (scour checks) from 6 km to 12 km which caused a high run off rate causing accumulation at Saiwa swamp.

The total soil moved in Sibanga-Kesegon was 3009.512 cm<sup>3</sup>, a total of 2476.484 cm<sup>3</sup> of debris were deposited along the road while 694.148 cm<sup>3</sup> was eroded. The general soil movement trend in Sibanga-Kesegon road is deposition. The deposited soil came from adjacent farms, this was evident by the inconsistency from eroded and deposited sediments.

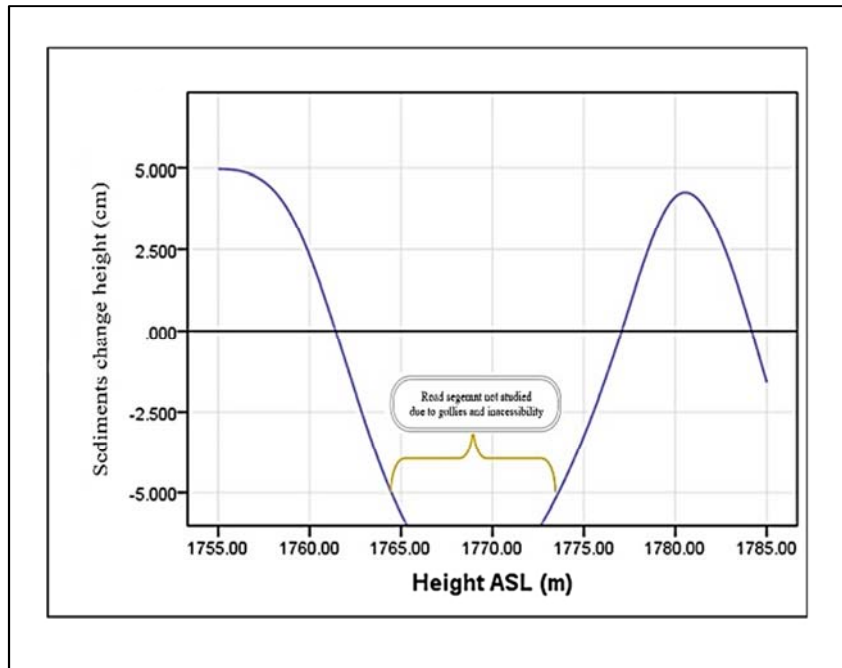
Figure 12. Line graph of eroded/deposited sediments change versus ASL in Sikulu-Kinyoro road.

Sikulu-Kinyoro lies on a rolling plain and it covers 8+200 km from Saboti Junction to Kitalale Junction in Kinyoro centre. The road rises from 1755-1809 m ASL at Kinyoro

centre. The road is generally covered with vegetation. At 5.6 km to 6 km on height of 1768-1773 m above sea level there was no data recorded due to large existing gullies.

The total sediments change in the road was 1011.47 cm<sup>3</sup>. The total sediments deposited was 574.34 cm<sup>3</sup> while eroded sediments was 437.14 cm<sup>3</sup>, the sediments eroded in the road reserve and the sediments deposited were almost equal. At 5+600 km of the road stretch from Saboti Junction there were large gullies that could have been caused by cumulative storm waters for a 2 km stretch.

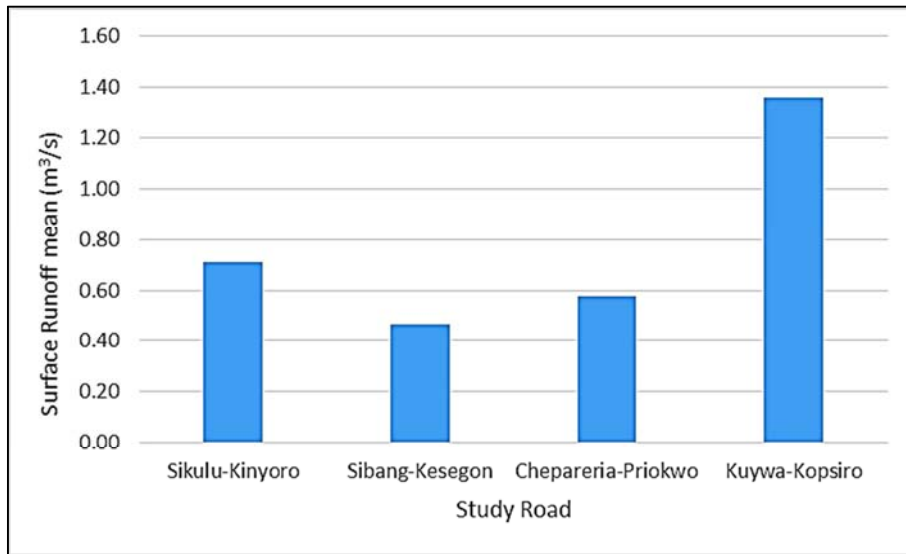
Figure 13. Bar graph of study roads run off rates in (m³/s).

Runoff rates for the road network were computed by cook's method, which factored in catchment characteristics of the catchment areas. A Pearson product-moment correlation coefficient was computed to assess the relationship between the sediments volume accumulated along roads and runoff rates along the study area. There was

a positive correlation between the two variables,  $r = 0.281$ ,  $n = 82$ ,  $p = 0.011$ . Generally, there was significant correlation between sediments volume and runoff rates in the study roads.

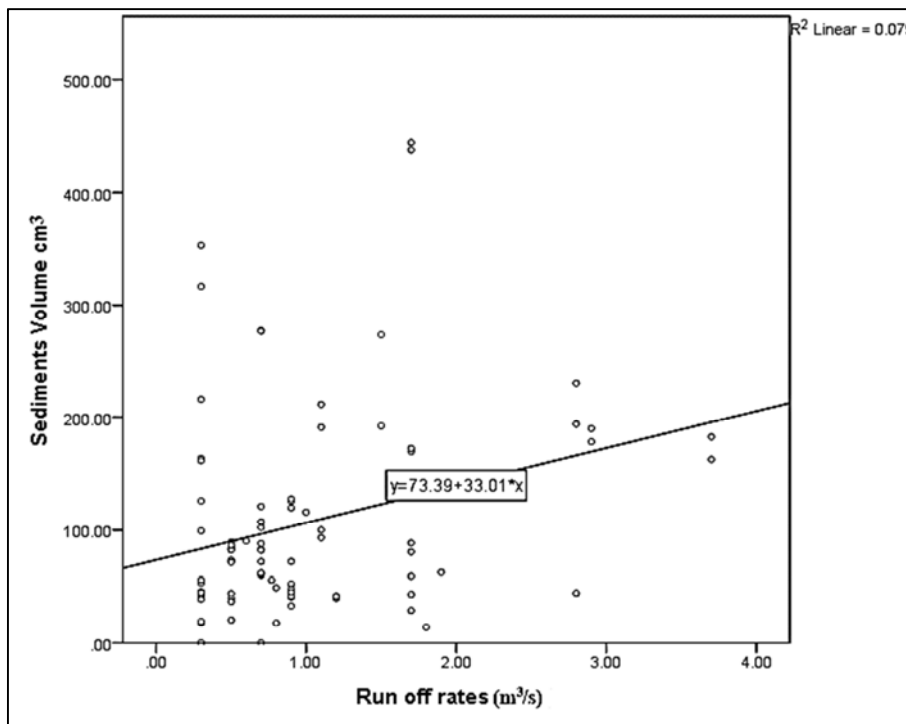
Figure 14. Scatter plot of sediments total volume versus run off rates.

Plotting the data on a scatter plot- see a scatter plot that summarizes the results in (Figure 14)- exhibits a general concentration rate below 1 m³/s.

The run off rates in all the roads concentrate on a mean of 1 m³/s with volume sediments of less than 100 m³. The correlation between run off rates and sediments volume in the roads shows a positive correlation of  $r = +0.079$ .

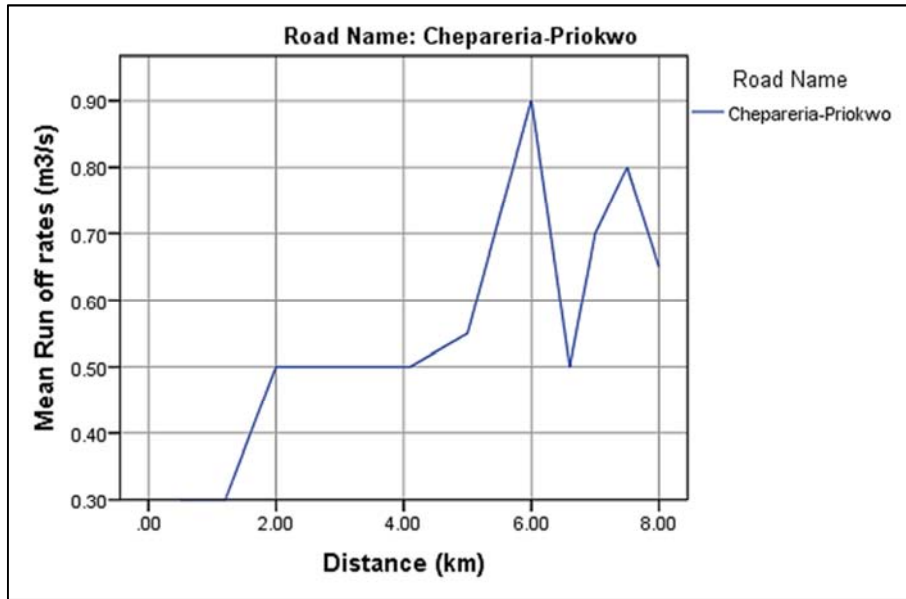
Figure 15. Mean run off rate versus distance (Chepareria-Priokwo).

The run off rate in Chepareria at 0+00 km is at 0.30 m<sup>3</sup>/s, this was the lowest speed because of the terrain and vegetation cover at the area, the surrounding had a heavy shrub growth and this helped in reducing runoff water speeds, this has also been documented by [10]. The rate increased and at 2km the speed of water was at 0.50m<sup>3</sup>/s and this was maintained until at 4 km. The stretch from 1.5 km-2 km was sloping towards the west and it featured large gullies and high rate of deposition. The slope could contribute to the increased surface run off within a 500 m stretch. A correlation of sediments volume versus run off rates were drawn,  $r=0.155$ ,  $n=20$ ,  $p= 0.515$ , there was significant difference between run off rates and sediments volume in the study road, this has been supported by [11] who indicated that surface runoff and sediments flow are directly proportional to the amount of runoff. From the above interpretation it is interpreted that surface run off is not responsible for the sediment deposits or erosion in the area and so others factors contributed to it and this included anthropogenic factors- human activities upslope or on the sides of the road.
